Manhole Inspection Summary

Manhole # S35S__018MH

Insp Date: **3/24/09 10:07 AM**

Location Address: **1227 S HANOVER ST**

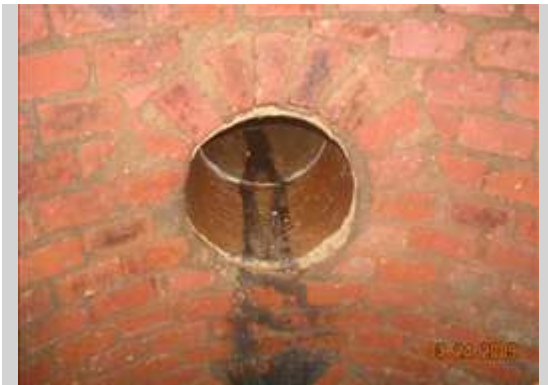
3 O'Clock Inflow

10 in. Circular Gravity Sewer
Pipe In @ 3 O'Clock

Drop In @ 3 O'Clock

Pipe Height: **10.8** (in.) Rod and Bar (Angled)
Pipe Material: **Clay** ☐ Pipe Lined
Invert Depth: **11.25** (ft.) Flow Characteristics: **Fast**
Deposits: ☒ None ☐ Mud ☐ Sludge ☐ Debris ☐ Grease
Silt Depth: **0** (in.) Deposits Extent:
Infiltration: **None** Pipe Seal Cond: **Sound**

Drop: **Outside** Rod and Bar
Angled: **Yes** Reading: **12.10** (ft.)
Inv Depth: **13.10** (ft.)
Drop Condition: **Partly Clogged**
